An appraisal of three historical stone posts discovered at Stainland, West Yorkshire

Dr Graham Cooper, Landscape Researcher.

17 July 2024

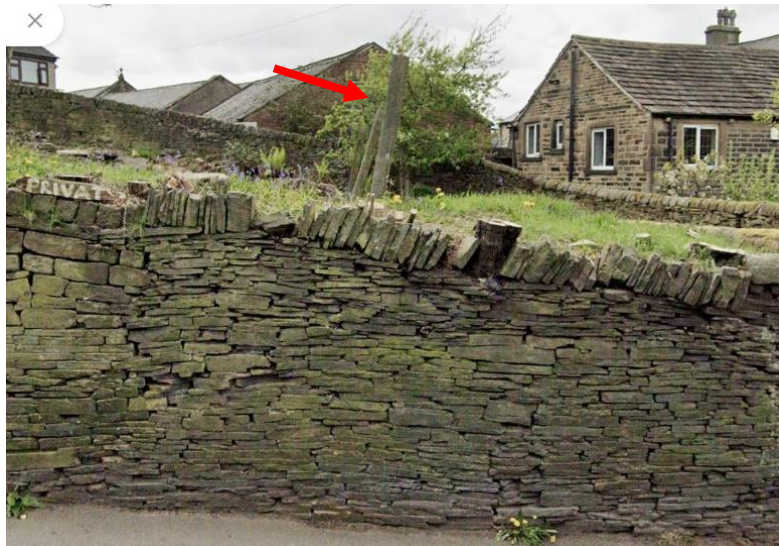
Figure 1. The site from the road, looking along the alignment of the posts (arrow).

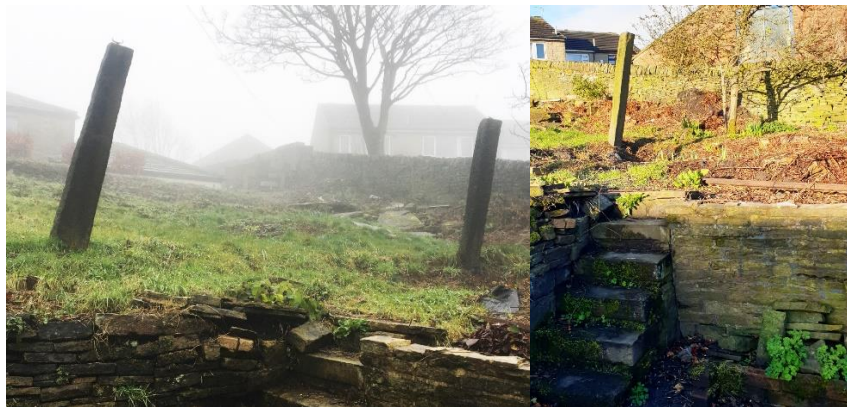
Photographs of the site and posts were provided by both correspondents (Figure 2).

Figure 2. Representative photographs provided by June Holden (left) and Lisa Fieldhouse (right).

Unfortunately, the posts were removed by builders to an unknown location before I had the opportunity to inspect them (I live some distance away). I provided a very brief initial assessment to both correspondents based on their few wide-angle photographs and work I had undertaken on large scale historical mapping to determine if they were shown on maps and marked as tenters. Inspection of 6-inch (1:10560) and 25-inch (1:2500) OS maps (the earliest 6-inch dating from 1848/49) did not reveal any tenters on the site, despite tenters being shown and labelled elsewhere on some of the same map sheets, including within the village.

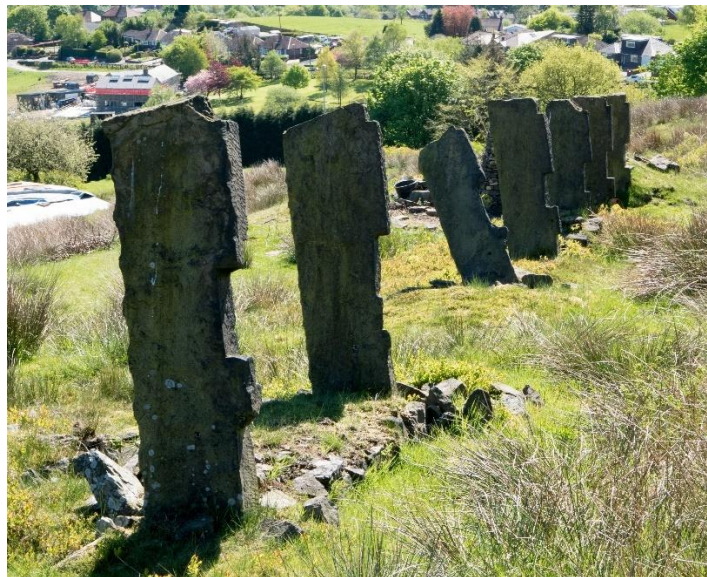
My review of the few authenticated stone tenter-posts still standing would lead me to expect features such as a long slot on one face (Figure 3) to accommodate the downward movement of the (usually) lower wooden tenterhook beams in the stretching process. The Stainland stone posts appear to have no facility to stretch cloth. This fact alone denies their classification as field tenters.²

Figure 3. Remains of stone tenter-posts near Wall Hill, Dobcross, dated c. 1840. The notch at the top would hold the fixed upper bar of tenterhooks, the extended notch below housed the mobile lower tenterhook bar to stretch the cloth evenly.

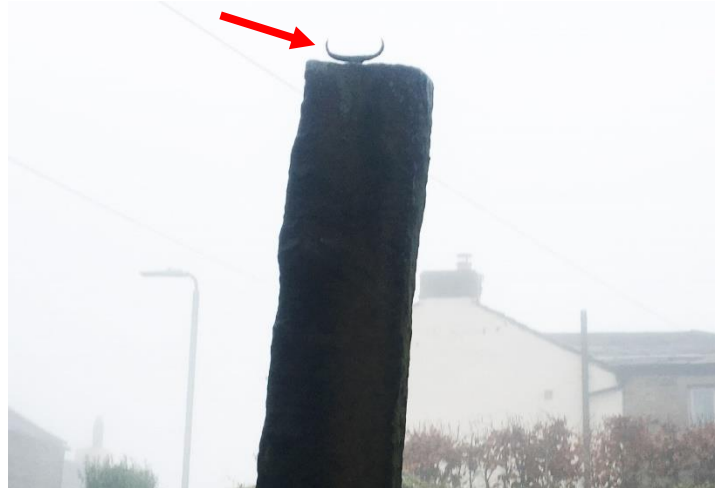
The iron structure on the post top has a bull-horn shape (Figure 4) and from the few photographs provided, appears to be aligned parallel to the post line. It is probably a cleat to support rope between the posts to hang the loose woollen materials to dry.³

Figure 4. The 'bull-horn' metal structure on the post tops.

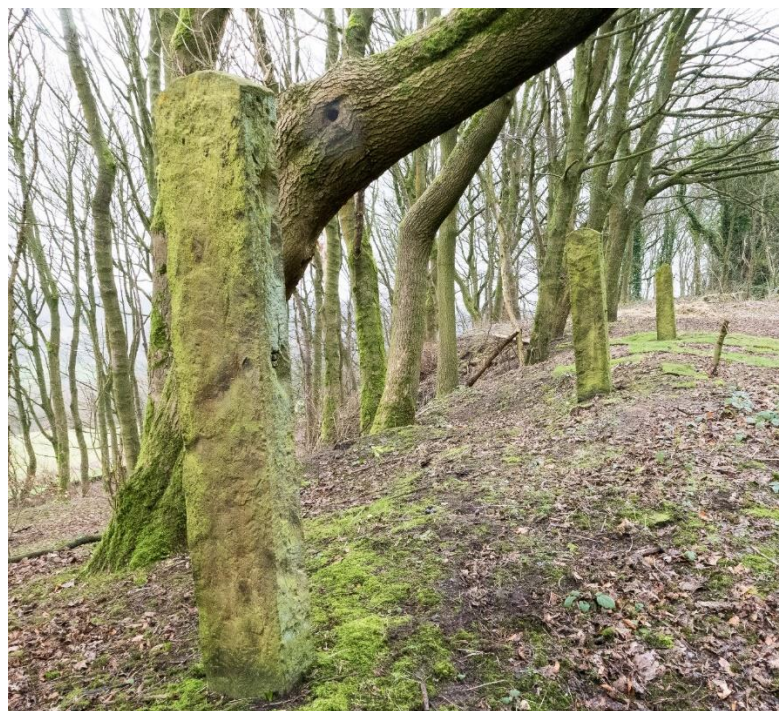
There is a similar line of posts at Petty Royd, nr. Pighill Wood, Huddersfield (SE09351737, Figures 5-7), but atop some of the undamaged posts are closed loops, with additional closed loops part-way down the posts to support additional ropes. I'm not aware of any statutory protection for these posts. They have also been described as tenters, but I consider them to be wool-posts. There is no evident facility to stretch cloth.

Figure 5. Posts at Petty Royd, Huddersfield. There are a further three posts behind the camera.

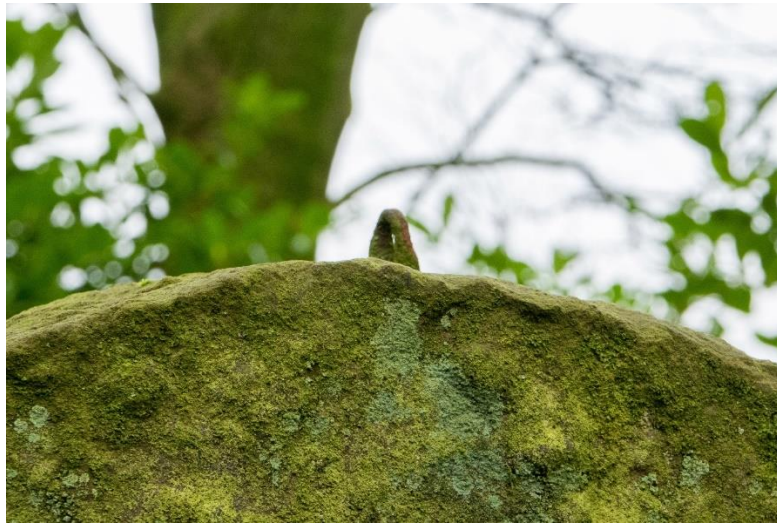
Figure 6. A closed loop on the crest of some of the undamaged Petty Royd posts, to accommodate a rope.

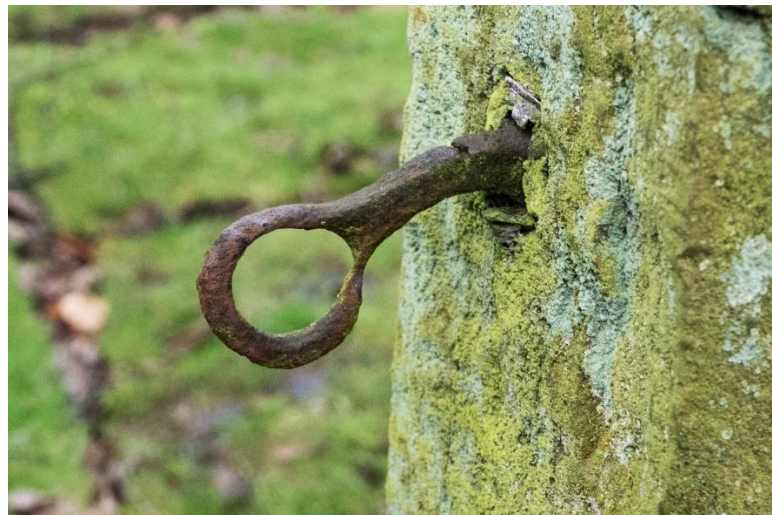
Figure 7. A closed loop about half-way down the side of the posts, aligned for rope to pass down the row.

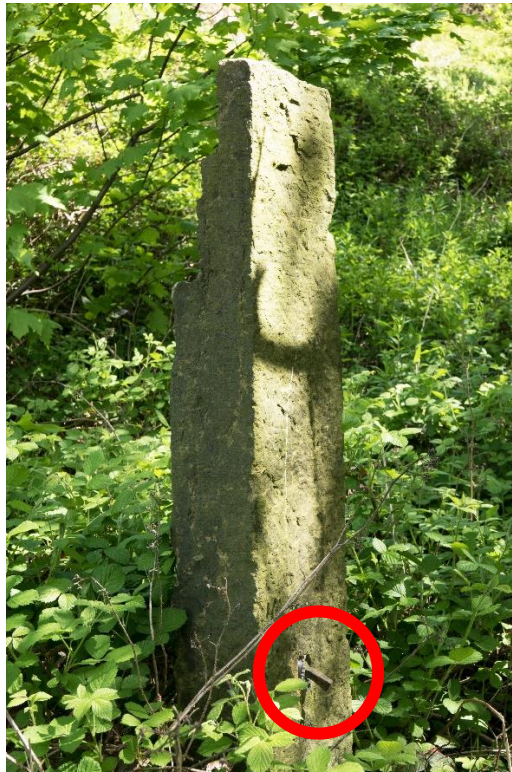
At Longwood Gate, Huddersfield, is a row of five stone posts set in urban woodland (SE10761698). They have the remains of a metal fitting on one face. Four of the tops are badly damaged (Figure 8). Interpretation of their function is difficult. They are classed as 'tenter posts' by Historic England and are listed Grade II.⁴ This is a questionable categorisation; they do not appear to have had a cloth-stretching facility. On balance, they are more likely to be wool-posts.

Figure 8. One of the damaged Longwood Gate posts. The remains of a metal fitting are highlighted.
